STRENGTHENING OF KEYED LONGITUDINAL CONSTRUCTION
JOINTS IN RIGID PAVEMENTS

ARMY ENGINEER WATERWAYS EXPERIMENT STATION

AUGUST 1972

Report No. FAA-RD-72-106

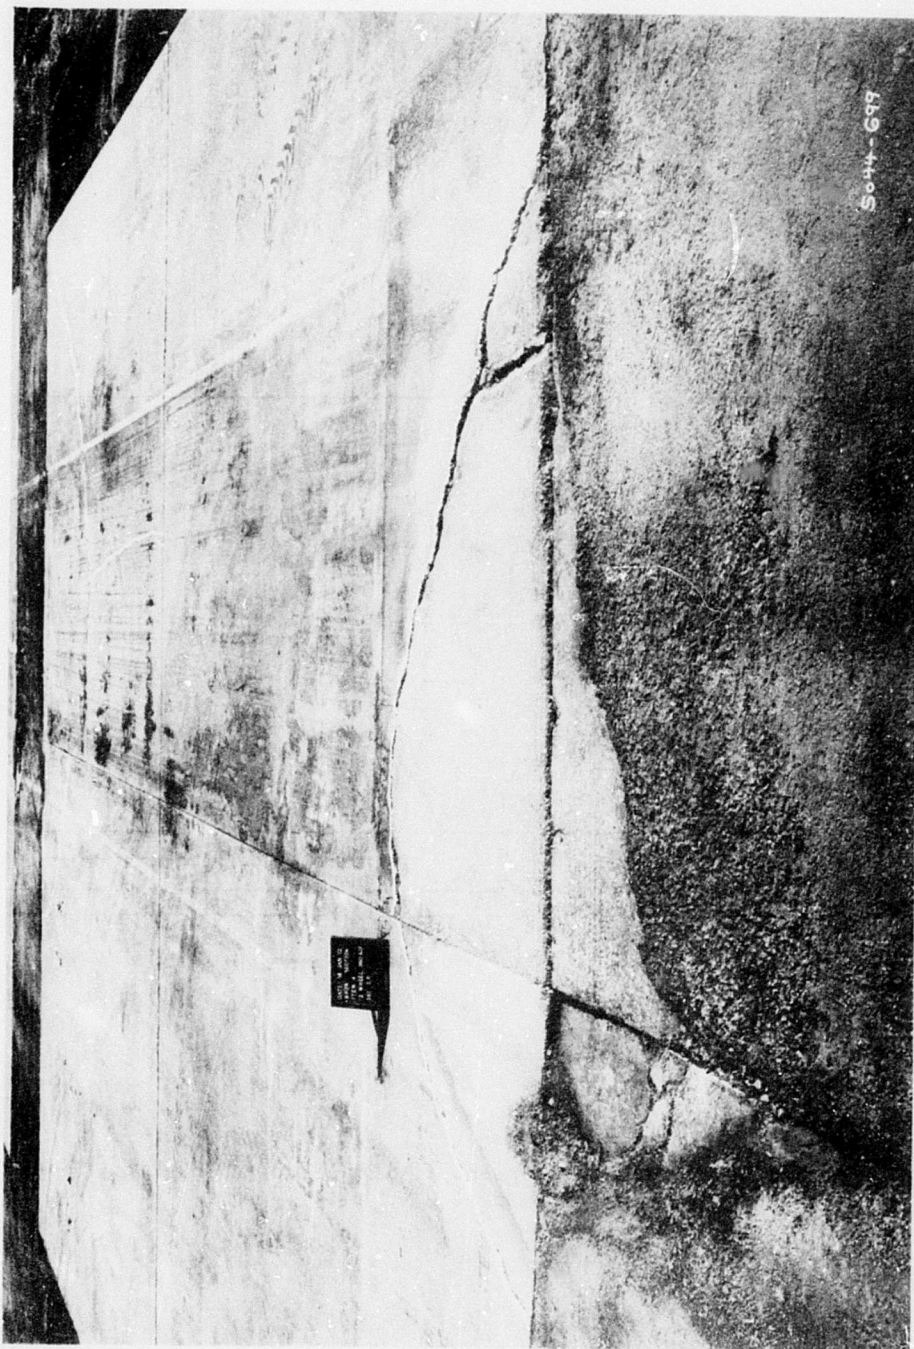
At the end of traffic (6336 coverages), the entire item was rated as in satisfactory condition, and the longitudinal construction joint was in excellent condition. Very little spalling was observed during the trafficking of this item. Traffic was discontinued because indications were that a large number of coverages would be required to produce a shattered-slab failure condition in the interior portion of the test item. It should be pointed out that the transition slabs were constructed directly on the clay subgrade during the initial construction of the MWHGL test section and were left in place for this test. This resulted in the pumping problem as discussed above. There was no evidence of subgrade pumping through the stabilized base course at any location in the test item.

Figure 57. Item 4, 360-kip, 12-wheel-assembly lane after 6336 coverages.

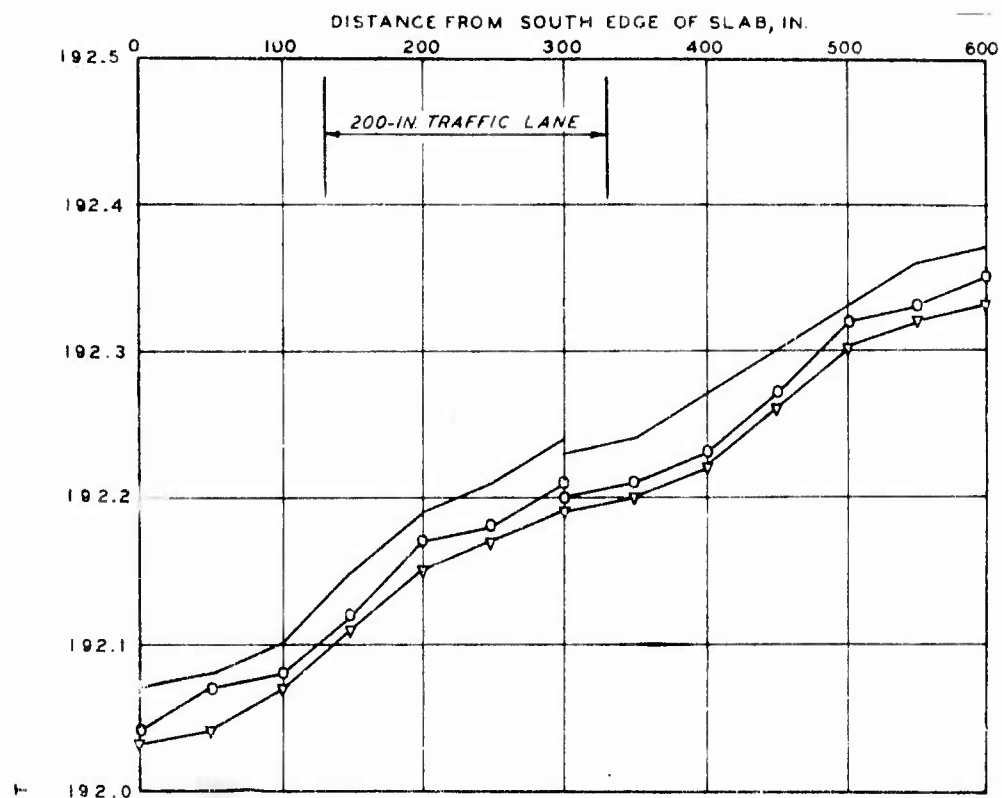
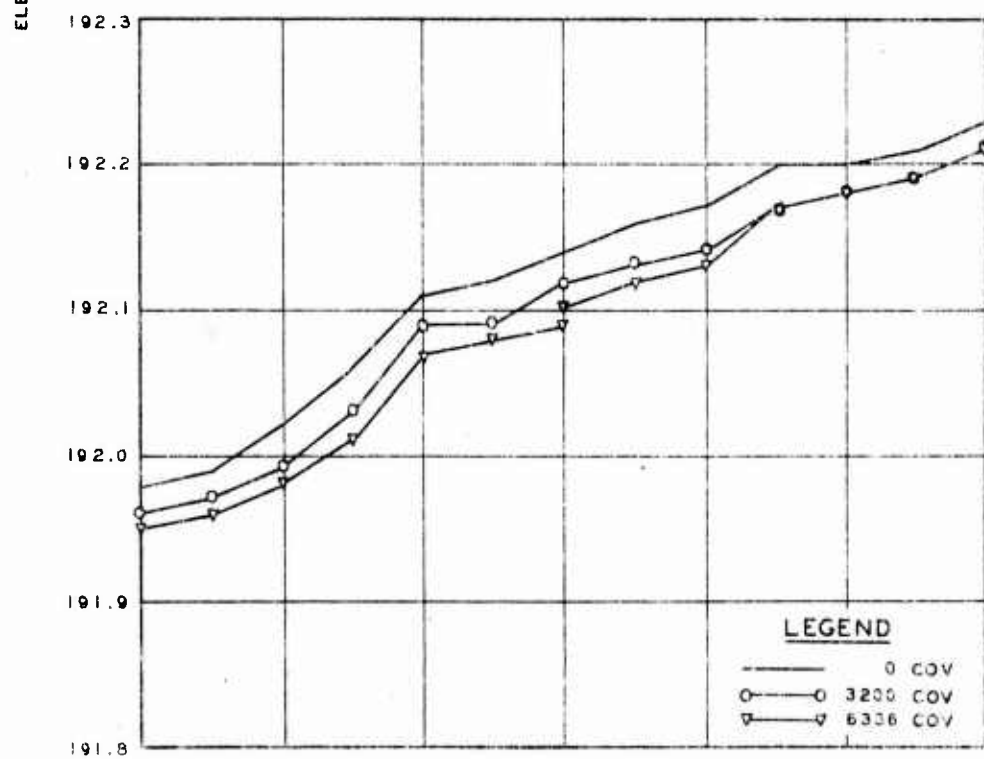
A typical cross section for this item indicating the permanent deformation due to traffic is shown in figure 58. The average permanent deformation was about 0.48 in. and the maximum deformation was 0.60 in. This plot indicates that about 75 percent of the average

Figure 58. Typical cross sections of item 4, 360-kip, 12-wheel-assembly lane.

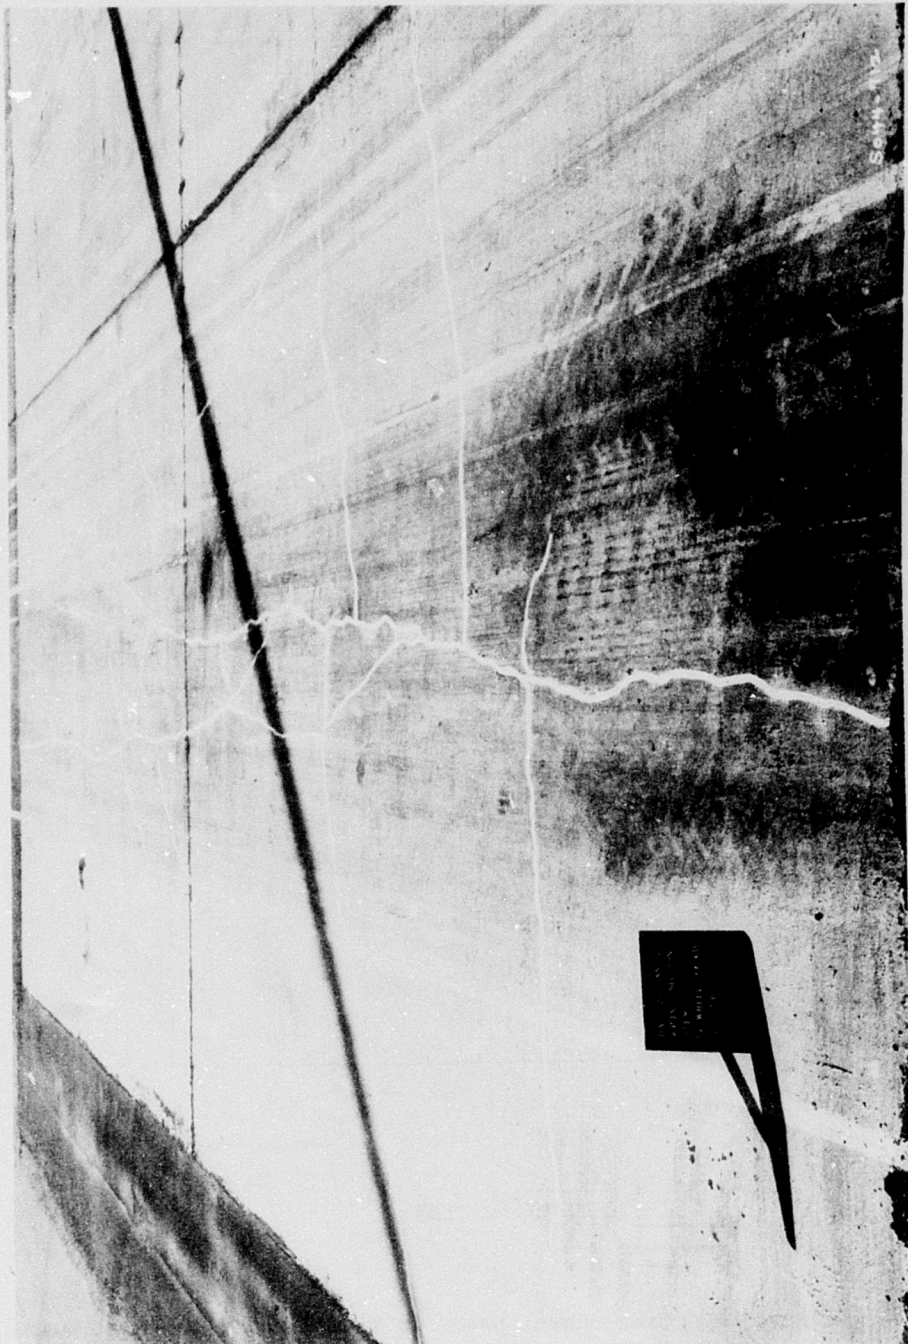
A general view of the item prior to traffic is shown in figure 60. As can be seen, both slabs contained cracks prior to traffic. The longitudinal crack in about the center of the traffic lane of the northwest slab was detected prior to the 12-wheel-assembly traffic; the remaining cracks developed during the 12-wheel-assembly traffic. When the twin-tandem traffic was commenced, pumping was observed at the existing longitudinal crack in the northwest slab. The initial crack due to traffic, a 6-ft-long longitudinal crack in the northeast slab, was detected after 4 coverages of traffic and continued to progress and extended the length of the slab after 35 coverages. After 35 coverages, several diagonal cracks and another longitudinal crack had developed in the northeast slab, and a longitudinal and several transverse cracks were observed in the northwest slab. Traffic was discontinued after 35 coverages when the item was considered to be a shattered-slab failure. A general view of the item at failure is shown in figure 61. The progression and extent of cracking during the traffic period is shown in figure 62.

Figure 61. Item 1. 166-k-in. twin-tandem-assembly lane after 35 coverages.

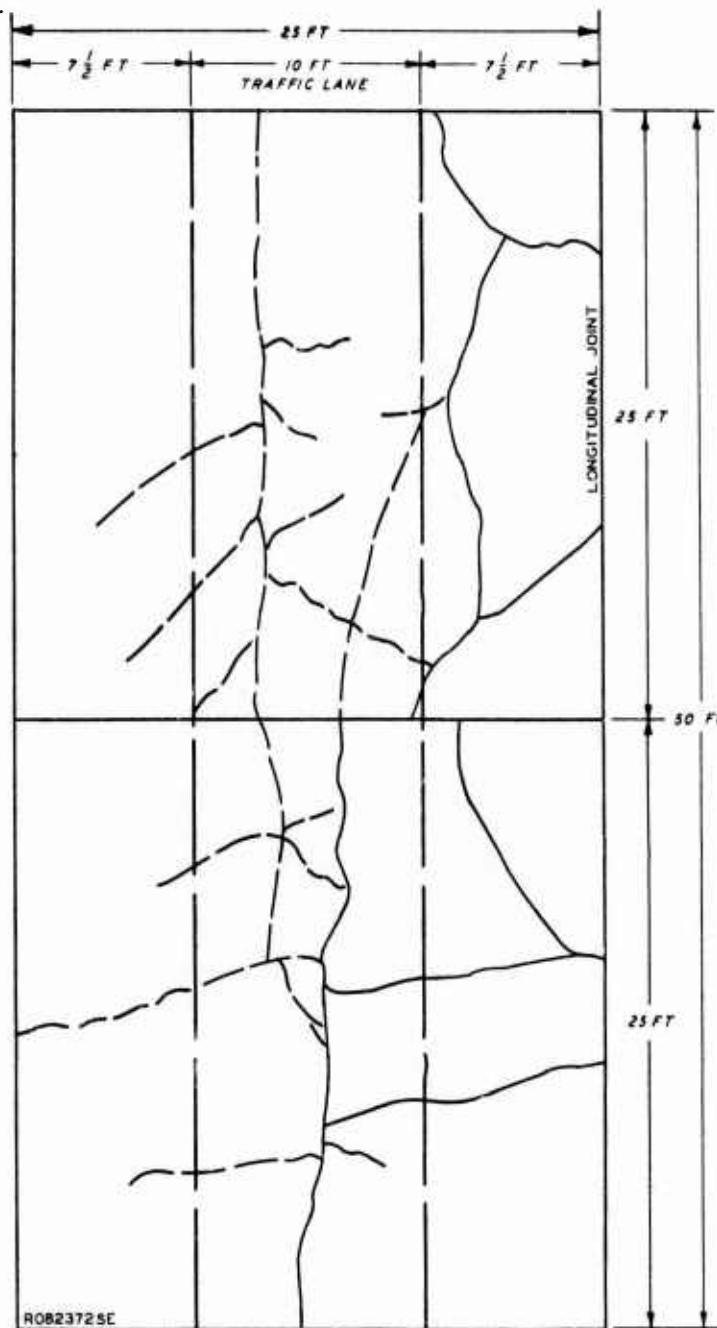
Figure 62. Crack development in item 1 under 166-kip, twin-tandem-assembly traffic.

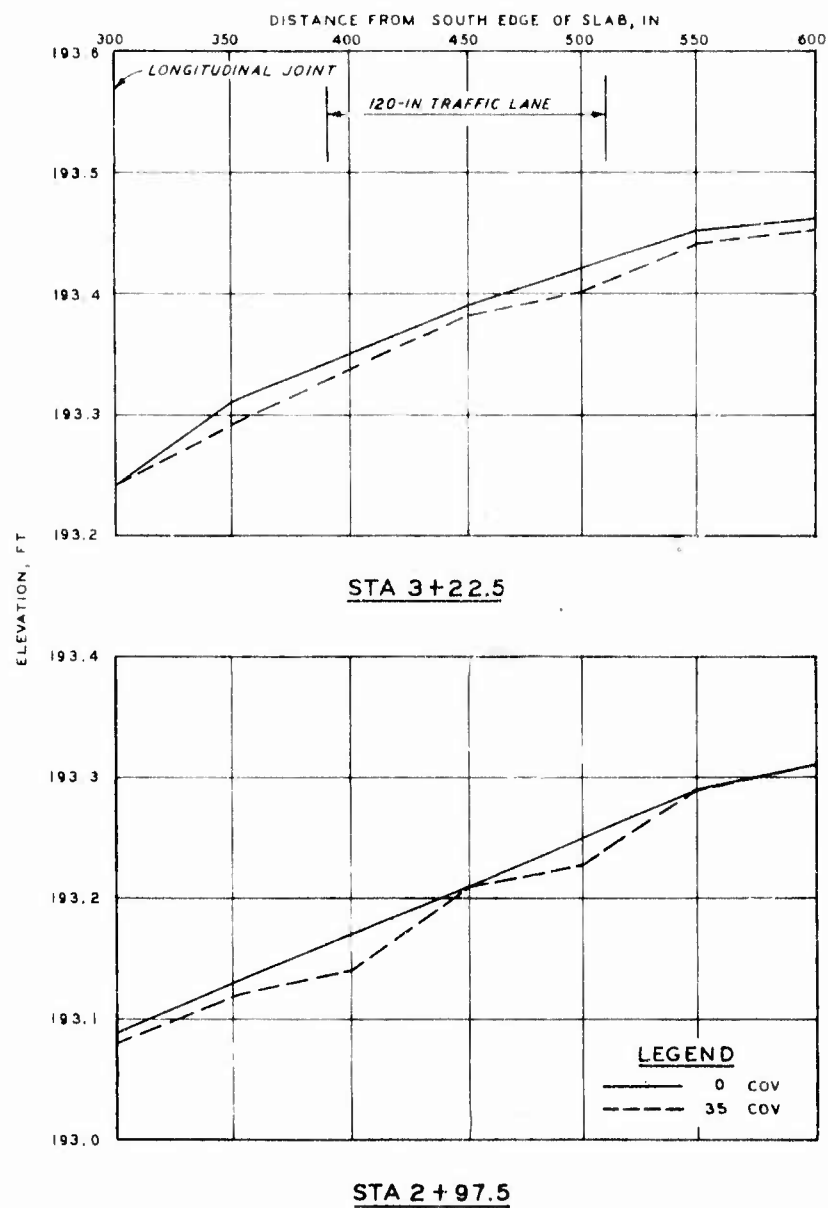
Typical permanent deformations, which occurred as a result of traffic, are shown by the typical cross-sections taken at the center of each slab (figure 63). An average deformation of about 0.15 in. and a maximum of 0.36 in. were recorded. The maximum total deflection measured prior to traffic was about 0.12 in. Plots of deflection measurements taken prior to traffic are shown in figure 64.

Figure 63. Typical cross sections of item 1, twin-tandem-assembly lane.

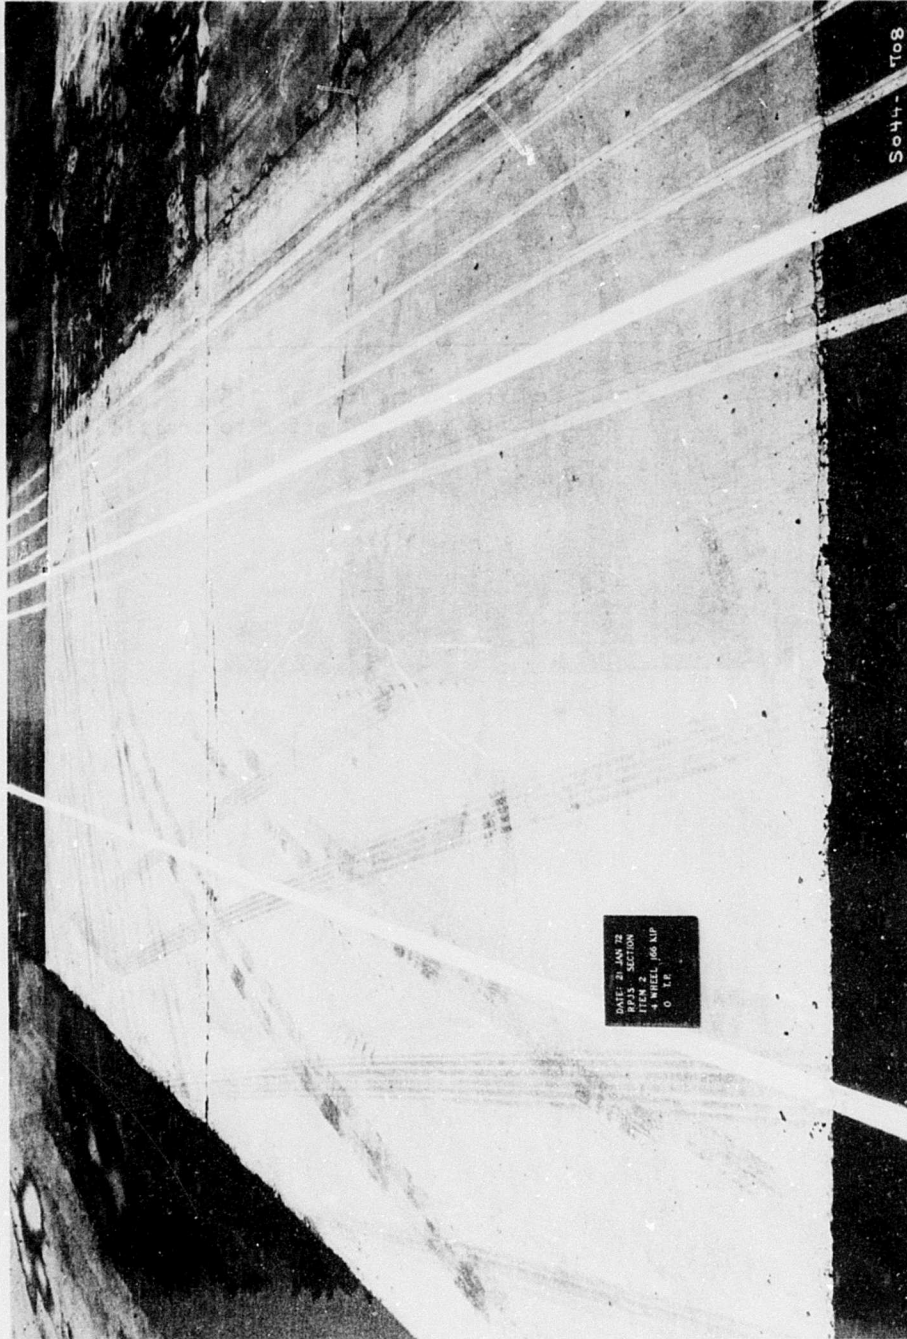
The condition of item 2 prior to traffic is shown in figure 65. Corner cracks were present in both slabs before traffic commenced. The first distress observed under traffic occurred at 120 coverages and consisted of longitudinal cracks commencing at either end of the item and running about 6 ft into the item. As traffic was continued, pavement cracking progressed rather rapidly. After 170 coverages, traffic was stopped and the item was considered to be a shattered-slab failure. At the end of traffic, both slabs contained several diagonal cracks, spalling and flaking were present at the existing cracks, and each slab was subdivided into six or more pieces. A general view of the item at failure is depicted in figure 66; a plot indicating the extent and progression of cracking during traffic is shown in figure 67.

Figure 65. Item 2, 166-kip, twin-tandem-assembly lane prior to traffic.

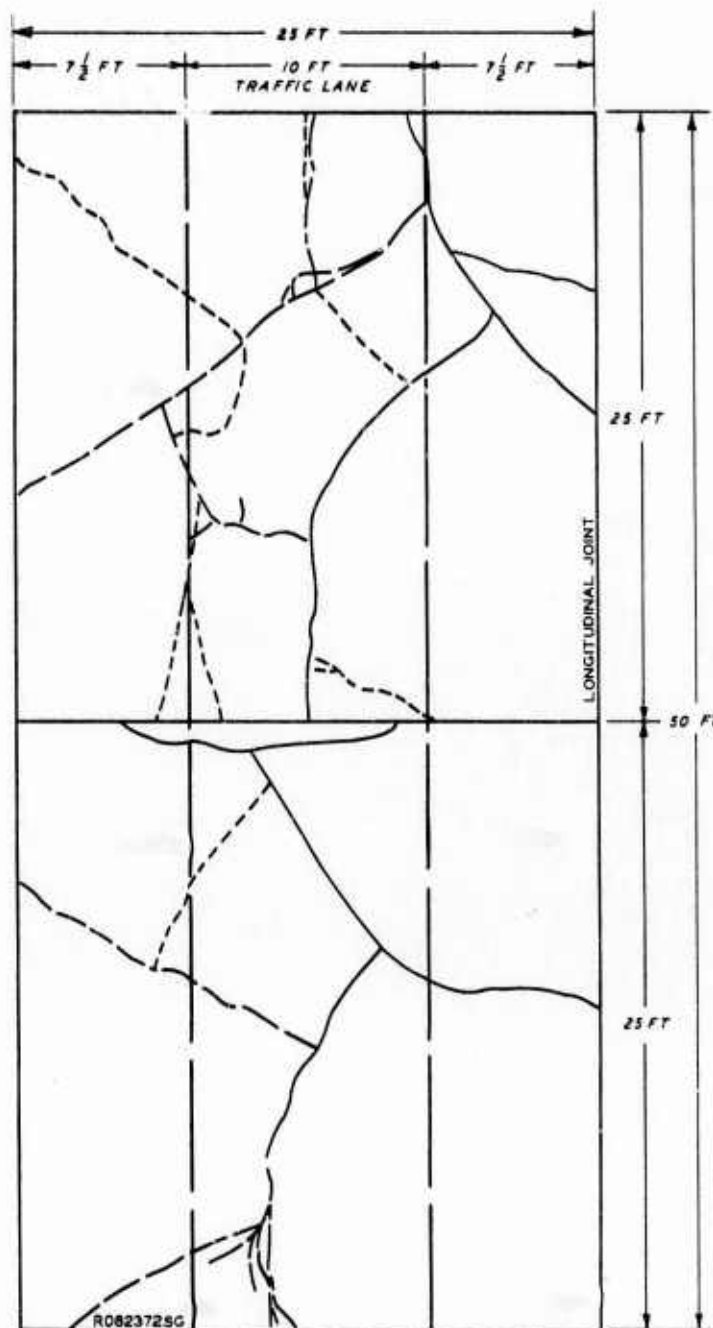
Figure 67. Crack development in item 2 under 166-kip, twin-tandem-assembly traffic.

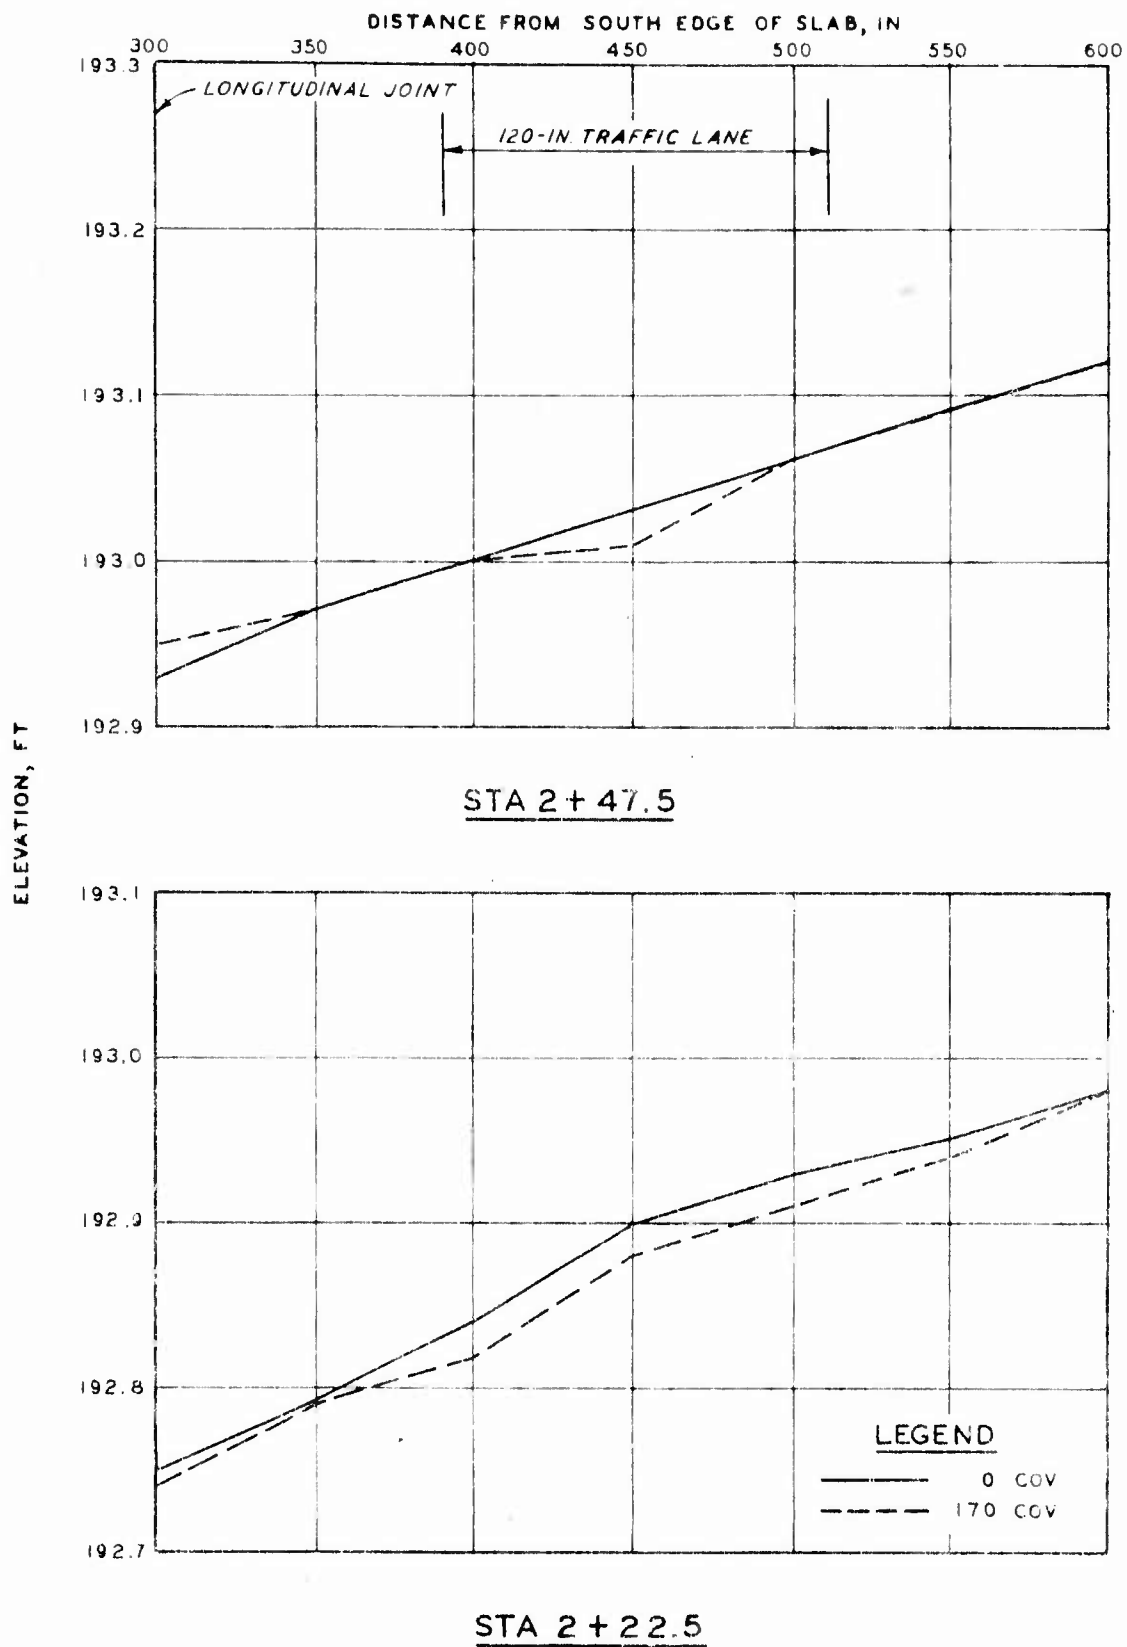
Typical cross-section plot showing the permanent deformation that occurred during traffic is shown in figure 68. The maximum deformation measured at the conclusion of traffic was 0.24 in. As shown in figure 69, a maximum total deflection of about 0.13 in. was measured prior to traffic.

Figure 68. Typical cross sections of item 2, 166-kip, twin-tandem-assembly lane.

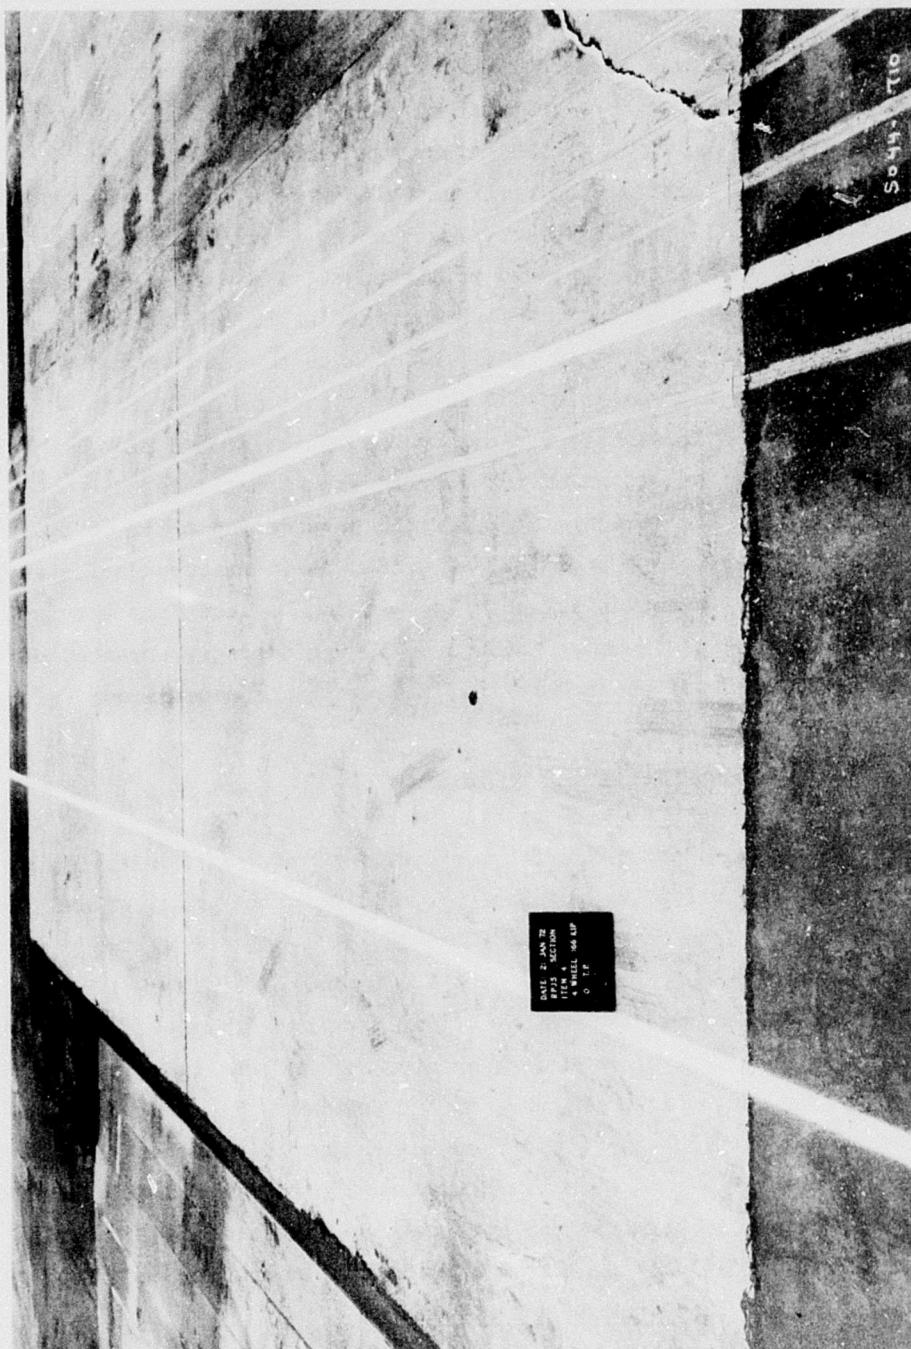
Prior to test traffic, there were corner cracks located at the southeast corner of the northeast slab and at the southwest corner of the northwest slab of item 4. Figure 70 is a general view of the item prior to traffic. The first crack observed during traffic was a hairline longitudinal crack in approximately the center of the traffic lane and extending the length of the item. This crack was detected after 320 coverages. Slight spalling of the existing longitudinal crack at the east end of the item was noticed after about 360 coverages. After 630

Figure 70. Item 4, 166-kip, twin-tandem-assembly lane prior to traffic.

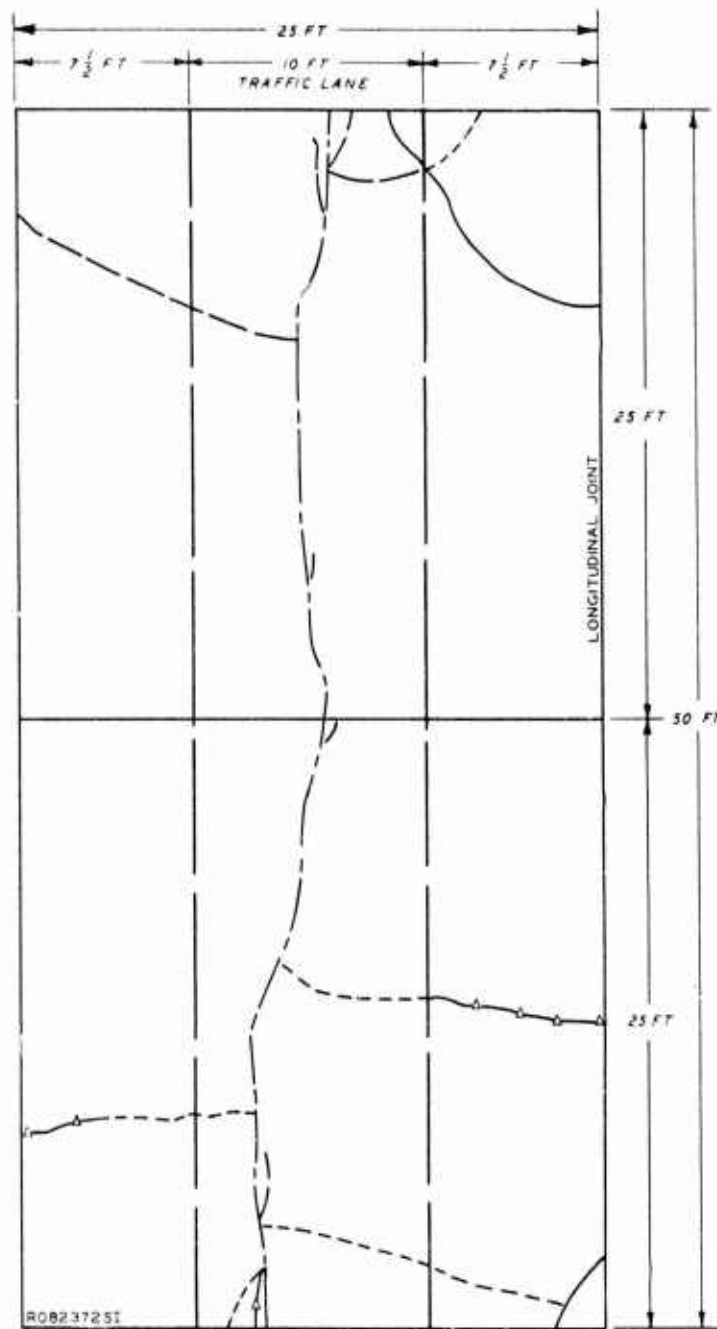
coverages, a crack was observed running diagonally from the north edge of the pavement to the longitudinal crack in the middle of the traffic lane. Small hairline cracks extending transversely out from the longitudinal crack in the northwest slab were observed between 710 and 880 coverages. At the 950-coverage level, the transverse cracks in the northwest slab had progressed to the edges of the slab, which resulted in subdividing the slab into the shattered-slab condition, and traffic was stopped. Spalling and flaking, such as that shown in figure 71, were evident along most of the cracks at the end of traffic. The progression of cracking is shown by the crack pattern plot in figure 72, and the final condition of the item is shown in figure 73.

Figure 72. Crack development in item 4 under 166-kip, twin-tandem-assembly traffic.

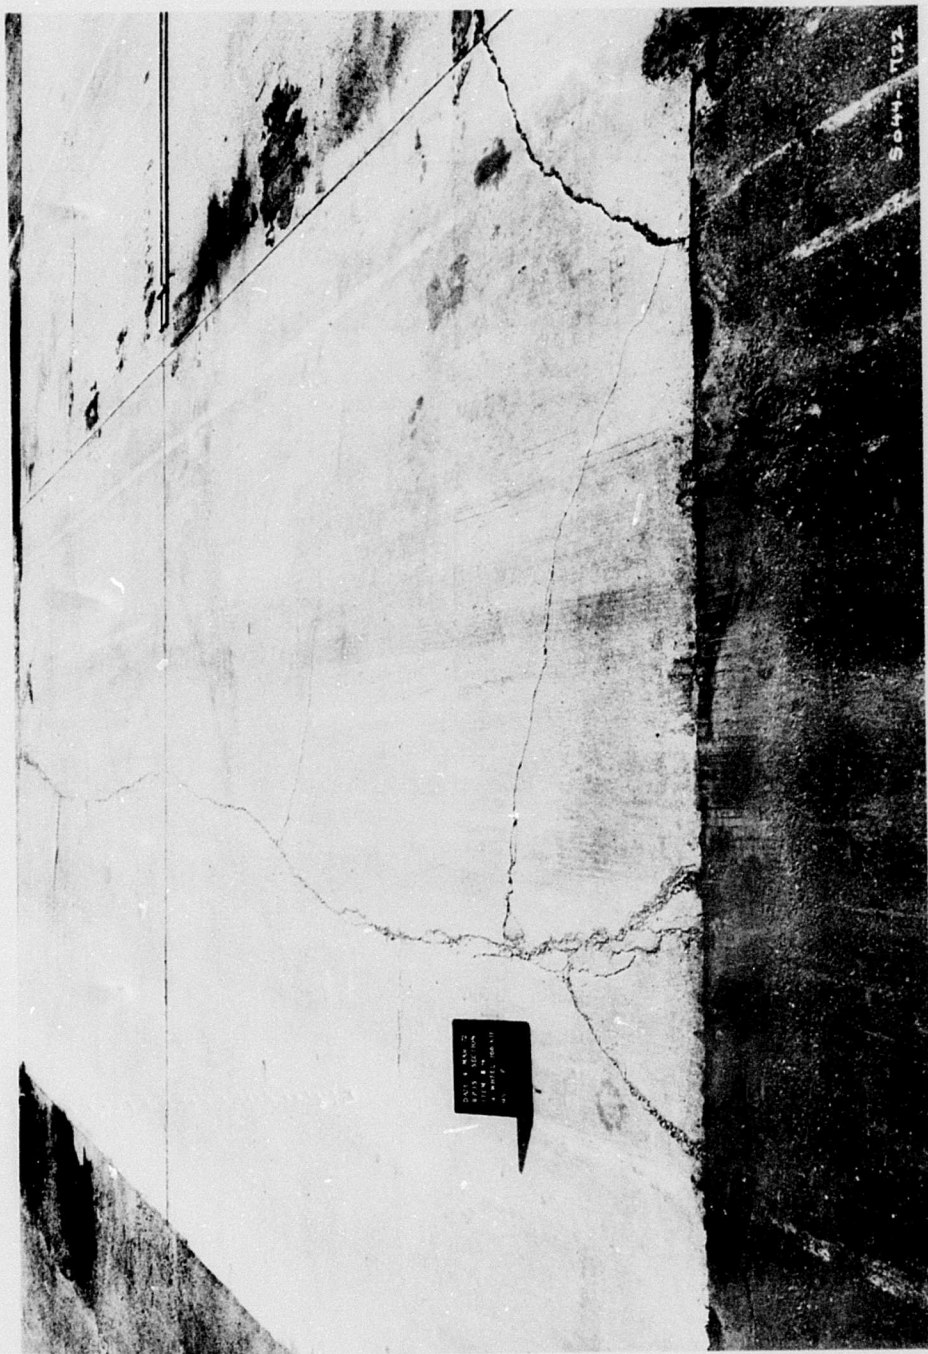
Figure 73. Item 4, 166-kip, twin-tandem-assembly lane after 950 coverages.

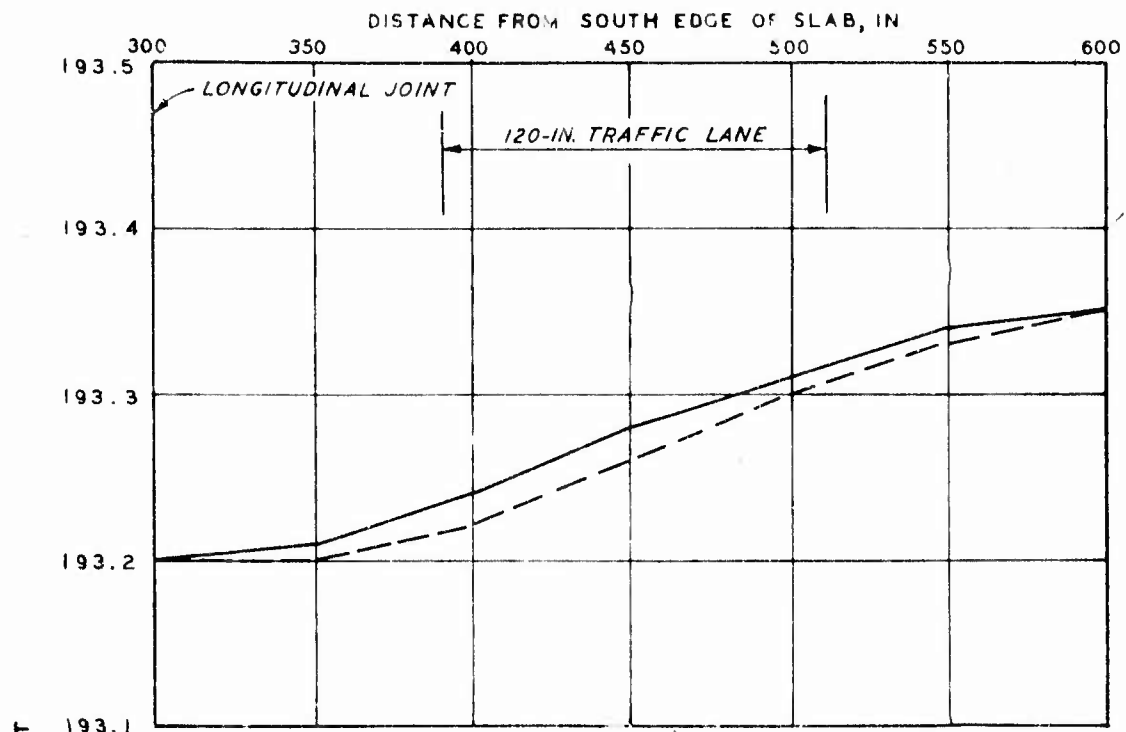
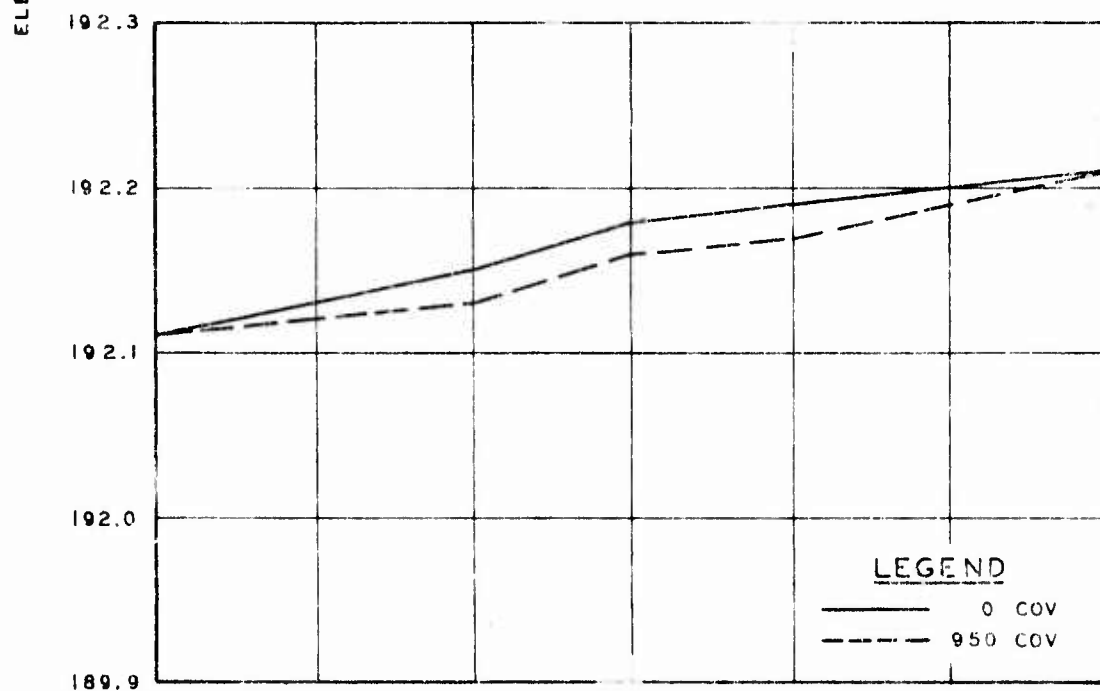
The maximum total deflection measured prior to traffic was about 0.09 in. A plot of the deflection basin measured before applying test traffic is shown in figure 74. As can be seen from the typical cross-section plots shown in figure 75, the average permanent deformation after failure was about 0.18 in., and the maximum permanent deformation was 0.24 in.

Figure 75. Typical cross sections of item 4, 166-kip, twin-tandem-assembly lane.
